**Comanche Springs pupfish
(*Cyprinodon elegans*)
5-Year Status Review:
Summary and Evaluation**

**U.S. Fish and Wildlife Service
Austin Ecological Services Field Office
Austin, Texas
2 August 2024**

5-YEAR REVIEW

Species reviewed: Comanche Springs pupfish (*Cyprinodon elegans*)

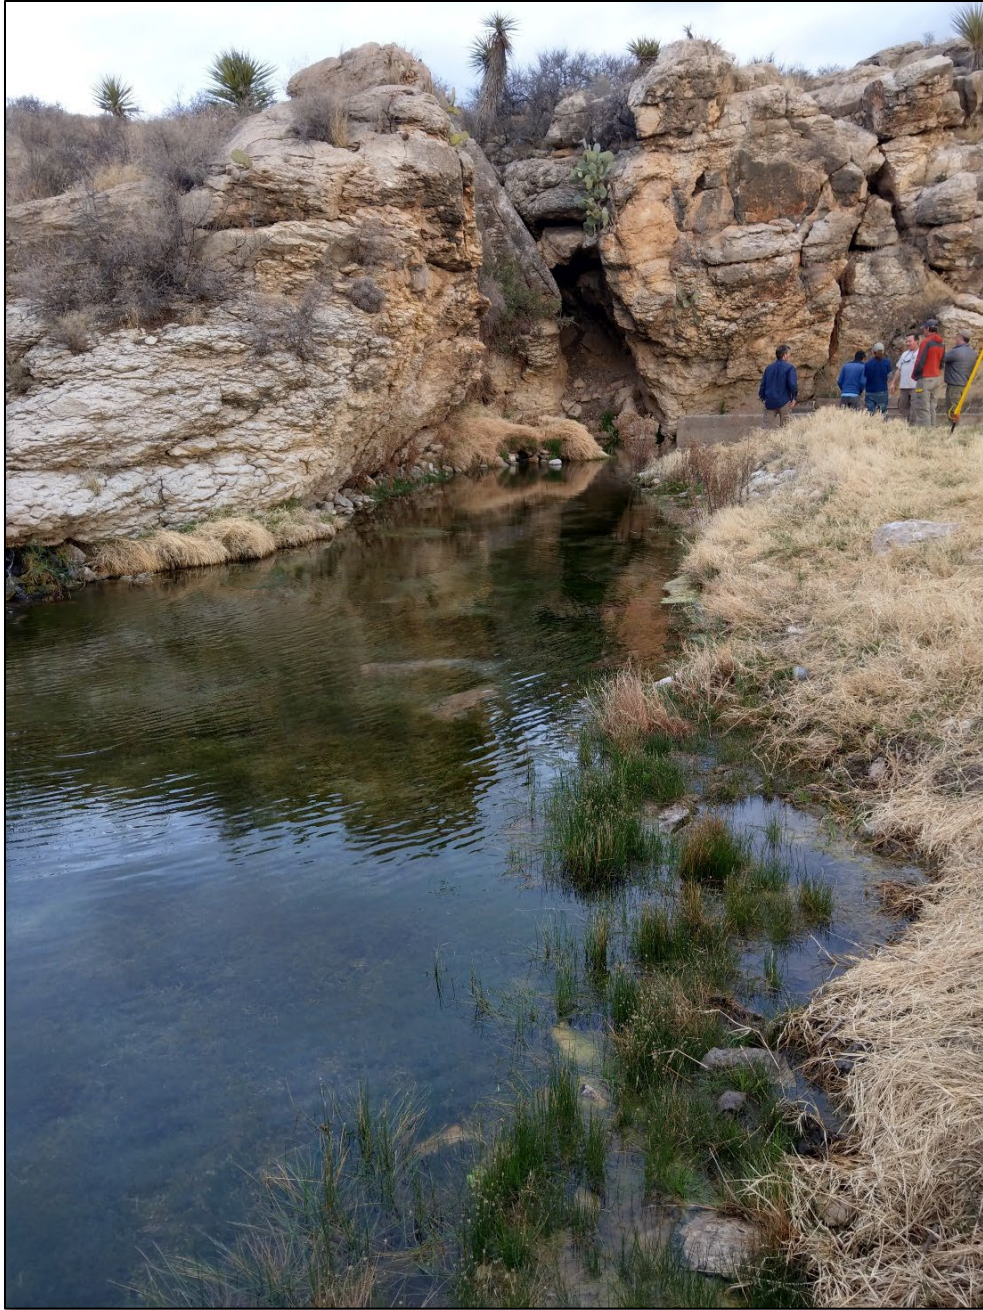
Figure 3. Phantom Lake Spring in February 2018. Photo by U.S. Fish and Wildlife Service staff.

In early May, a staff member with the Bureau of Reclamation contacted the Texas FWCO to inform them that based on their camera feed, the pumps that maintain the refugium were not functioning (Montagne 2022a, p. 1). We infer that the electricity had been shut off between when the land transfer was finalized and when this notice was received. The Texas FWCO project leader and a Bureau of Reclamation staff member both attempted to contact the landowner and ranch manager (Montagne 2022a, p. 1). In a conversation in late spring 2022, the landowner stated that he had told his ranch manager to turn off the electricity to the pump system (Montagne 2024, p. 1). Based on that information and the history of the site, the Service determined in early June that the refugium dried up by the time that conversation took place (Montagne 2022b, p. 1). This status was confirmed via a site visit in February 2023 (Montagne 2023, pp. 1–2, Figures 3 and 4).

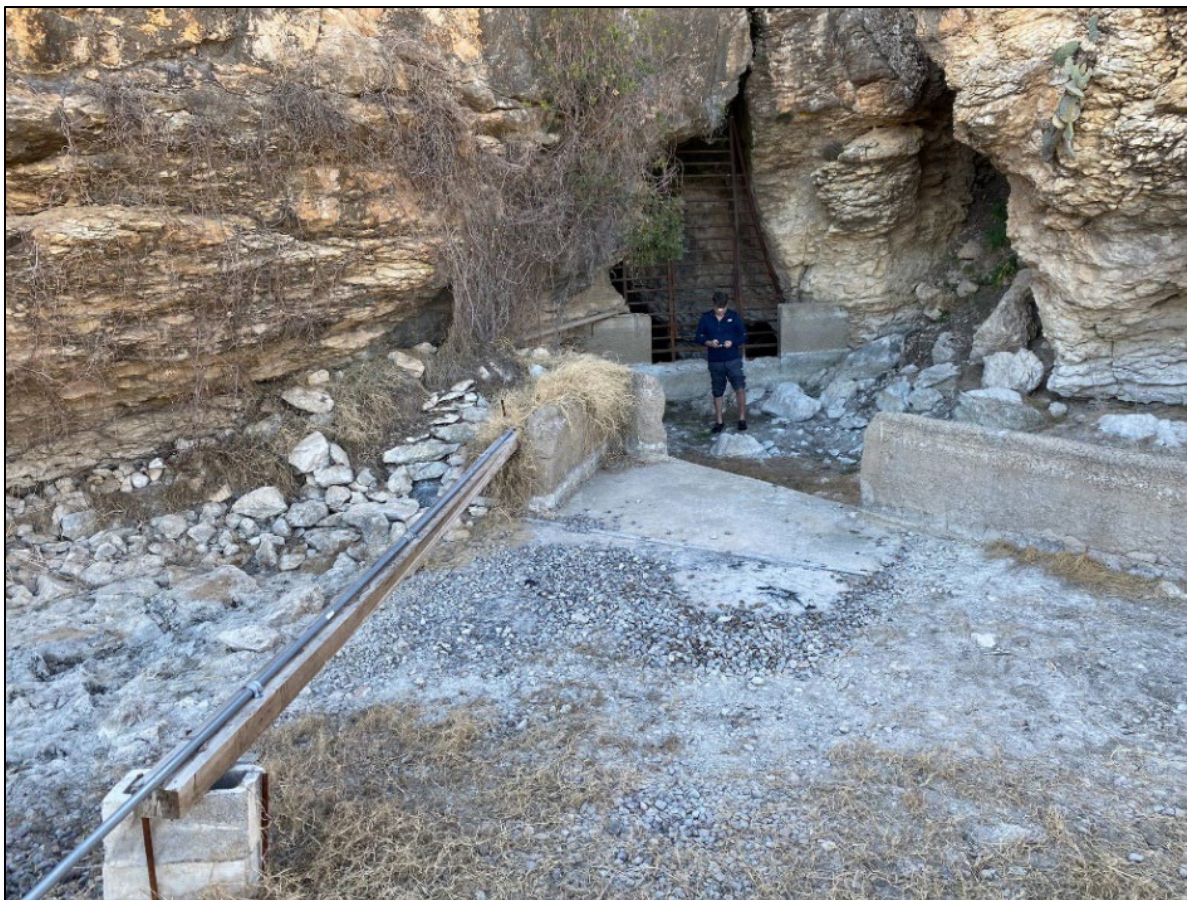
Figure 4. Phantom Lake Spring in February 2023 after the pumps that maintained the water levels in the refugium were turned off. The site has been dewatered and the image reflects the current status quo for the site. Photo by Mike Montagne, U.S. Fish and Wildlife Service.
